Looking at the Paint Layers of the Grand Entrance Hall, Brunel Museum, Using Block Sectioning, Optical Microscopy, and Scanning Electron Microscopy

**Candidate Number: ZNBW8
ARCLG 123: Conservation Material Science
Assignment 2/2
Due: 22 April 2013
Word Count: 3790/4000**

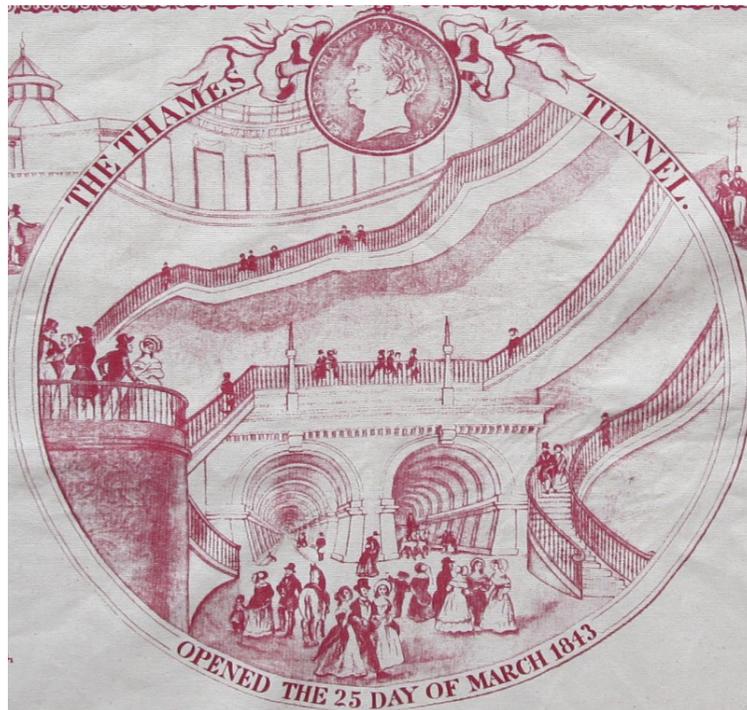
Figure 1: A poster created from an enlarged print on a handkerchief

The current floor of the Grand Entrance Hall was placed halfway up the original height of the shaft, slightly below the upper level staircase, as seen in this figure. Written accounts and depictions of the Grand Entrance Hall and tunnel space, as well as the active descent into the tunnel can still be seen today (Drew, 1852; Mathewson *et. al.*, 2006; Brunel Museum Web 2012). Image courtesy of the Brunel Museum.

One significant factor of the Grand Entrance Hall lies in that it had provided a direct passage to the underground tunnels, called the Thames Tunnel or the Brunel Tunnel (see **Figure 1**). This tunnel represents the first to have successfully been constructed underneath a navigable river as well as the first that was tunnelled in soft ground (Mathewson *et. al.*, 2006). It is seen as a “wonder of the modern world” (Cruickshank 1995) and the “birthplace of the tube” (Time Out, 2012), now a vital part of everyday London life.

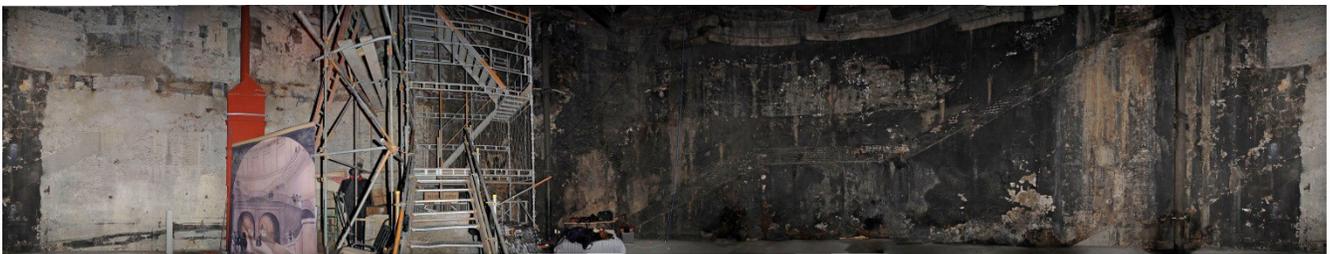
Figure 3: Panoramic photograph of the Grand Entrance Hall, Brunel Museum

As part of the documentation phase of the Grand Entrance Hall at the Brunel Museum, a panoramic photograph was created using a Nikon D700 (using 3.5 f-stop; 1/60 second exposure time; 200 ISO speed). Photographs were taken at 10° intervals to ensure optimal overlap and subsequently rectified using Photoshop CS5. Image courtesy of Stuart Laidlaw. Larger image available in **Appendix A**.

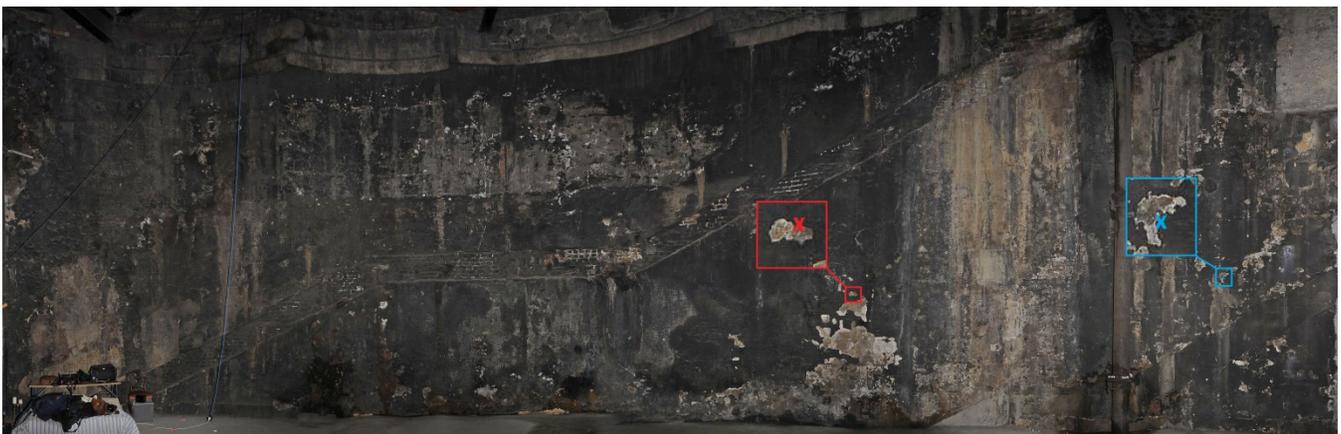
Figure 5: Samples taken from section of the Grand Entrance Hall, Brunel Museum

Pictured above is a section of the panoramic photograph of the Grand Entrance Hall, Brunel Museum. This section of the panoramic photograph depicts a section of the wall with easily removable surface layers. The red box depicts an enlargement where the red x indicates the origin point of Sample A. The blue box depicts an enlargement where the blue x indicates the origin point of Sample NN.

Samples were taken from the Grand Entrance Hall during the survey process. As mentioned previously, the collecting of the paint samples occurred concurrently with the materials survey and condition assessment, which took place over two days. Prior to this, a visual analysis of the site was undertaken, as was documentary research. During the survey, two samples were taken. Sample A was taken from within the parameters of the initial sample survey area, while Sample NN was taken from outside the initial sample survey area (see **Figure 5**).

Small samples (approximately 1 cm x 1 cm) were collected from surface that was easily removable. This easily removable surface indicates a painted layer atop the stonework. Both samples were taken from roughly 5 feet above ground. They were removed from the edges of pre-existing damaged regions which exposed the stone substrate so as to minimise visual loss. They were removed using a scalpel blade.

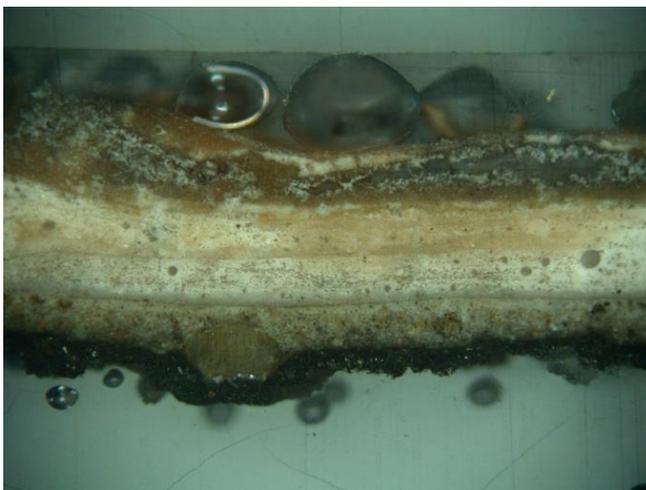
Figure 6: Central portion of Sample A under 50x magnification

The black layer orientated at the top of the photograph is the topmost layer, while the bottom layer is the layer

closest to the stone substrate of the Grand Entrance Hall, Brunel Museum.

Optical microscopes are used to magnify objects and can provide information about the structure and characteristics of the sample (Stuart, 2007). Where paint may appear similar to the naked eye, they show very different crystal properties at a microscopic level (Stuart, 2007). Both Sample A and Sample NN were examined under the microscope using 50x, 100x, and 200x magnification (see **Figure 6** and **Figure 7**).

Optical microscopy has provided further understanding into the irregularity of the easily removable surface of the Grand Entrance Hall. Magnification has provided an understanding into the differentiation of grain sizes present within the previous surface coatings. The results reveal at least four previous surface coatings underneath the black layer, visible from **Figure 5** and **Figure 6**. This can be discerned not only by differences in grain size, but by differences in general colouration as well.

Optical microscopy has revealed that in both samples, wet paint had been applied over dry paint throughout the history of the reapplication of surface coatings. This can be seen by the separation at the interface between layers.

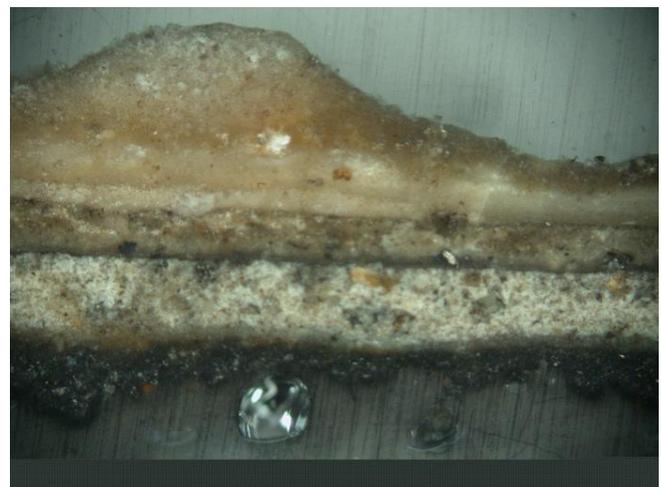
Figure 7: Central portion of Sample NN under 50x magnification

The black layer orientated at the top of the photograph is the topmost layer, while the bottom layer is the layer closest to the stone substrate of the Grand Entrance Hall, Brunel Museum.

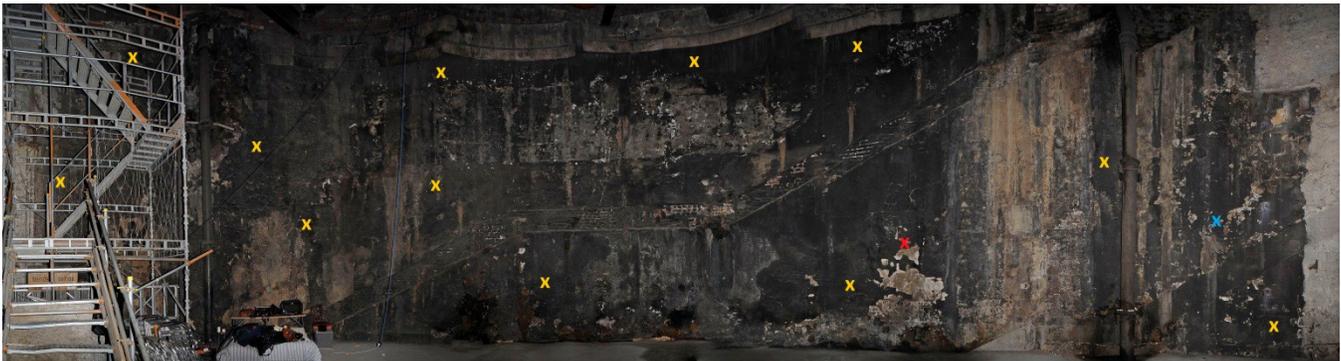
Figure 11: Potential sampling strategy taken from section of the Grand Entrance Hall, Brunel Museum
Pictured above is the section of the panoramic photograph of the Grand Entrance Hall, Brunel Museum with easily removable surface layers. The red x indicates the origin point of Sample A and the blue x indicates the origin point of Sample NN. Taking into account areas of poor condition (as noted by the condition survey), the above schematic is one possible strategy where the yellow xs denote potential areas for future sampling.

If the line of the original staircase is accepted as a feature original to the time period in which the Grand Entrance Hall was used as an attraction, then it may stand to reason that any frescos would be in the space above, and therefore easily viewable. Therefore, any potential frescos may be higher up than in the space sampled.
